RE: Request for Information (RFI) Pursuant to Section 308 of the Clean Water Act
Yachtsmen's Cove Inc. (NYR00E462)
Docket No. CWA-IR-16-001

Water Compliance Inspection Report

Compliance Evaluation Inspection: Yachtsmen's Cove	
Inspection Date: July 21, 2015	Inspection Time: 12:30 PM – 1:30 PM
EPA Inspector: Christopher Mecozzi, Environmental Engineer, USEPA Region 2, DECA, Water Compliance Branch, (212) 637-4262	
Also On-Site: Marissa Abbruscato, Life Scientist, USEPA Region 2, DECA, Water Compliance Branch, (212) 637-4293	
Yachtsmen's Cove On-Site Representative: Ernie Firpo, Owner (516) 546-6026	
Site Information: 696 South Main Street, Freeport, NY 11520 SPDES No. NYR00E462 Owner/Operator/Permittee: Ernie Firpo, Owner 696 South Main Street Freeport, NY 11520

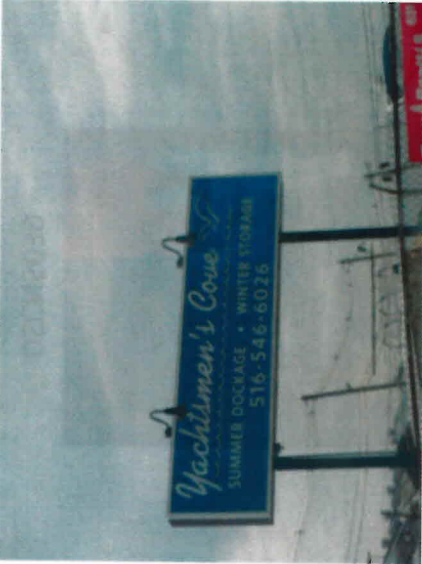
Photographic Log (Nikon Coolpix AW100) Freeport, NY –Yachtsmen’s Cove Inc. (Un-edited photos taken by Marissa Abbruscato, Scientist, USEPA Region 2, Water Compliance Branch, July 21, 2015).	
Photo ID	Description
DSCN5033	Sign at front of marina.
DSCN5034	Page 1 of Stormwater Pollution Prevention Plan (SWPPP).
DSCN5035	Page 2 of SWPPP.
DSCN5036	Page 3 of SWPPP.
DSCN5037	Page 4 of SWPPP.
DSCN5038	Page 5 of SWPPP.
DSCN5039	Blurry photo of petroleum storage.
DSCN5040	Petroleum storage area around back of shop.

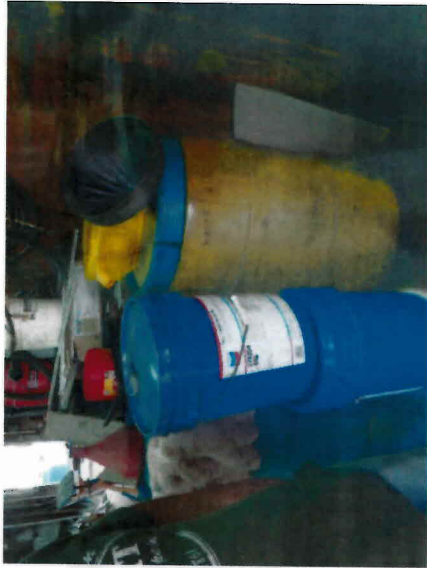
2. As shown in photograph DSCN5041, 55 gallon drums and paint canisters were not stored on containment pallets inside the maintenance garage. Materials should be stored on secondary containment pallets to minimize the potential for spills and leaks.

DSCN5041	Waste oil containers, Planet Earth Recovery comes to pick up.
DSCN5042	Permitted discharge drain that leads to bulkhead.
DSCN5043	Patron cleaning engine over open water.
DSCN5044	Fish cutting station on marina dock.
DSCN5045	Potential unpermitted discharge from bathroom sink and floor drain.
DSCN5046	Bathroom adjacent from potential unpermitted discharge point.
DSCN5048	Bathroom adjacent from potential unpermitted discharge point.
DSCN5049	Permitted discharge point from drain on property.
DSCN5050	Fish cutting station on marina dock.
DSCN5051	Large 60 metric ton mobile lift where power washing, oil changes and other maintenance procedures are done.
DSCN5052	Drain on lift pad with PVC pipe.
DSCN5053	Thick black substance inside drain on lift pad.
DSCN5054	Potential unpermitted discharge from drain on lift pad.
DSCN5055	Overview of potential unpermitted discharge from drain on lift pad.
DSCN5056	Dark photo of pipe channels underneath bathroom with potential illicit discharge to bulkhead.

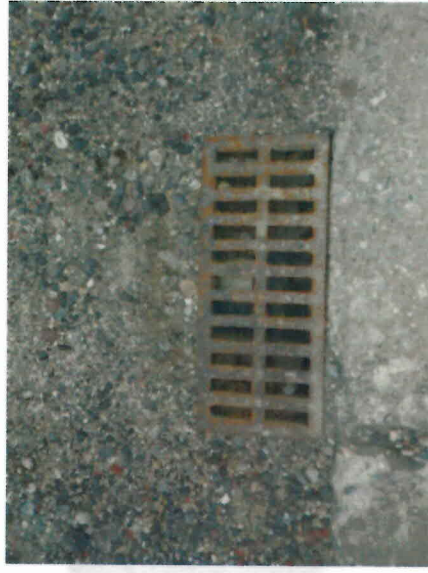
DSCN5042

catch basin in the parking lot and discharges directly to the bulkhead into the Hudson Canal (see photograph DSCN5042).

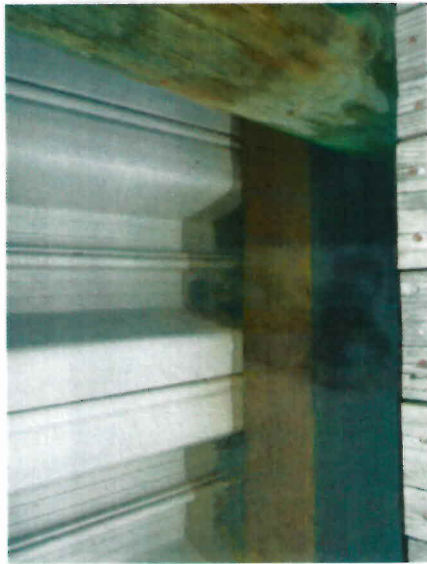
DSCN5045

The facility maintains one bathroom on-site. The bathroom is located approximately 25 feet from the bulkhead of the marina. EPA inspectors observed an unknown pipe in the bulkhead directly in line with the on-site bathroom (see photograph DSCN5045). Inspection of the bathroom/floor drain plumbing indicates a potential illicit connection to the bulkhead (see photographs DSCN5056-DSCN5059).

- b. As shown in photograph DSCN5045, a PVC pipe in the bulkhead of the marina was observed directly adjacent from the on-site bathroom, approximately twenty-five (25) feet away. Further inspection of the bathroom piping/plumbing underneath the structure revealed a potential connection from the bathroom floor drain to the PVC piping located in the bulkhead (photographs DSCN5056-DSCN5059). Part III.C.7.f of the Permit requires that the Facility eliminate all non-stormwater discharges not authorized by this general permit or another SPDES permit. Non-stormwater discharges that are not listed in Part I.C.3 to surface waters of the State which are not authorized by a SPDES permit are unlawful and must be terminated.

1. A formal, written response to the enclosed CEI Report (including photo documentation, where applicable) that describes how the Potential Noncompliance Items and Areas of Concern have been or will be addressed;
2. Any information in regards to the Catch Basin located in the concrete slab below the travel crane, including but not limited to;
 - a. Drywell photographs and design calculations,
 - b. Solids removal and vendor information,

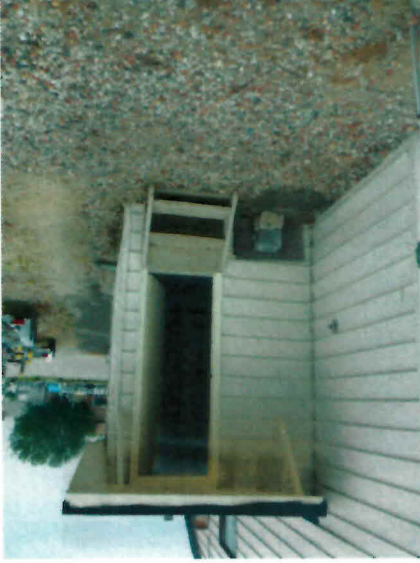
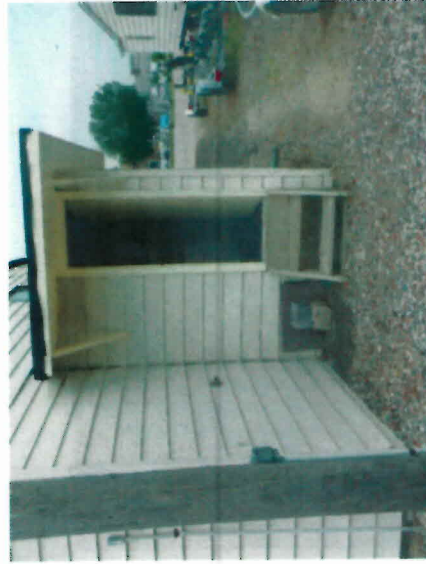
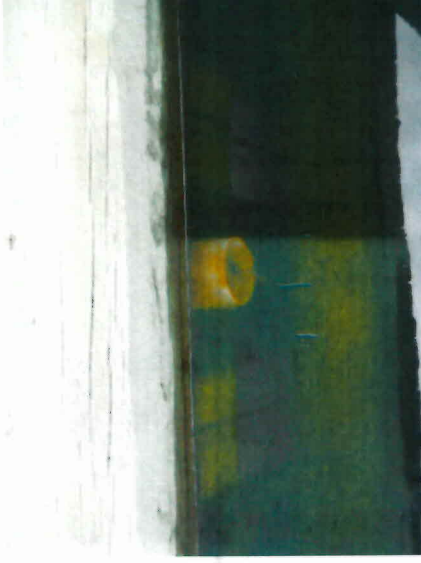
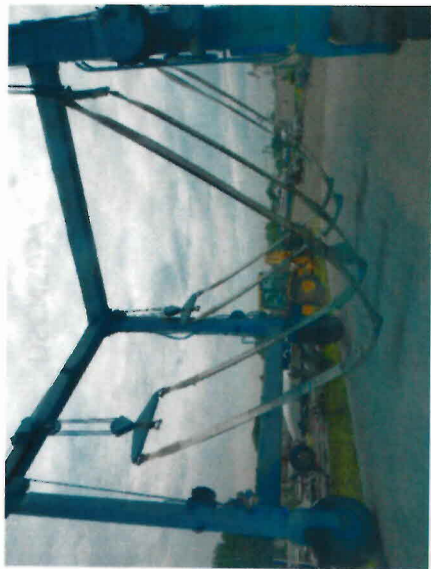
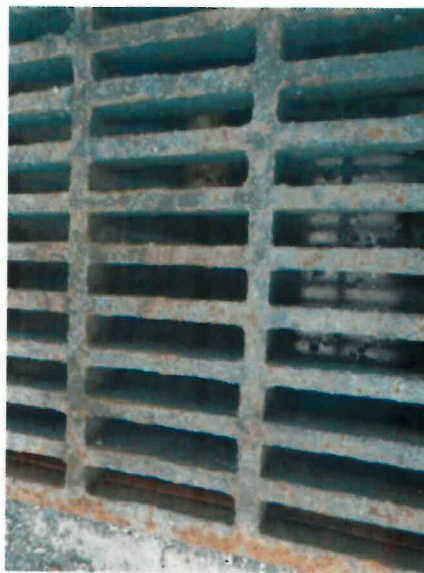
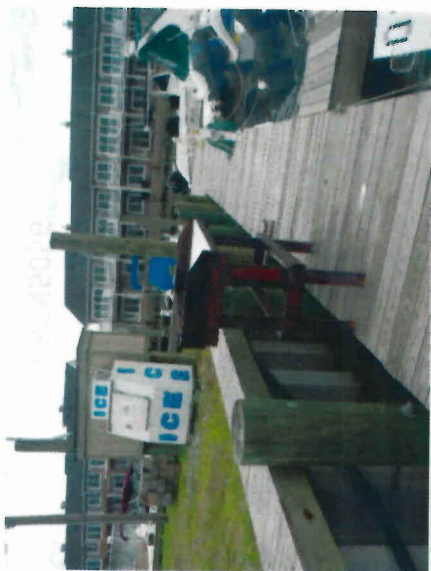
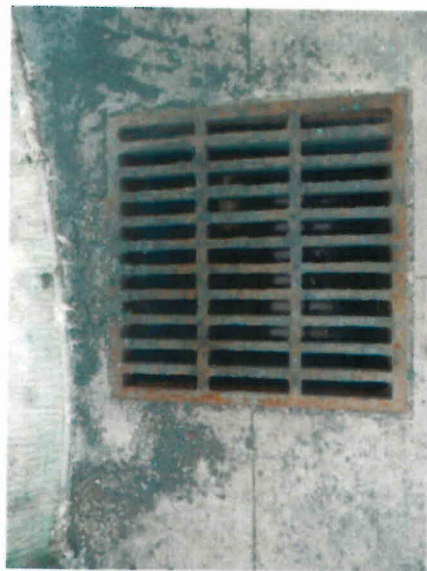
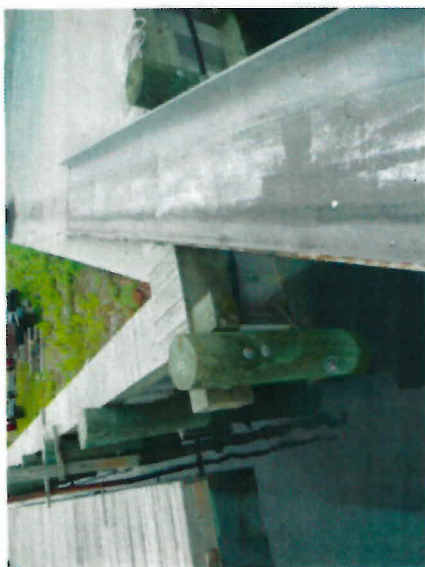
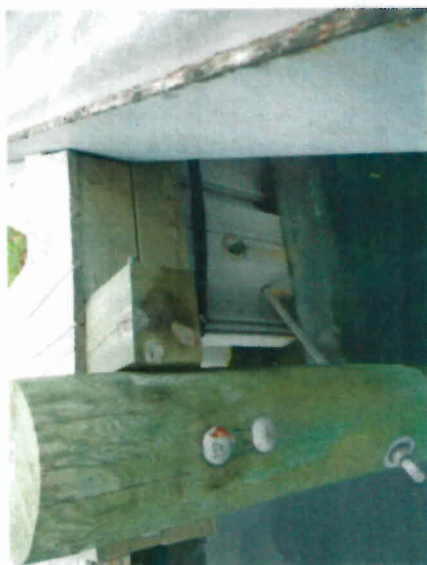
The facility is a full service marina, with approximately 125 slips available. At the time of the CEI, the marina had roughly 60-65 slips filled. According to Mr. Firpo, the marina performs all general maintenance activities which include, power-washing, bottom painting, oil changes, hydro-blasting, and other boat and engine repairs. The Facility stores all waste oil on-site until a subcontractor, Planet Earth Recovery comes to pick it up. The marina does not provide fueling or pump out services. The marina consists of a gravel parking lot, a full service garage/shop, an office building, an on-site bathroom, docks and two portable hydraulic lifts. The smaller lift is less frequently used is roughly seven (7) tons. The larger more frequently used lift is mobile and is approximately sixty (60) ton (see photograph DSCN5051). EPA inspectors observed a catch basin underneath the larger lift (see photographs DSCN5052-DSCN5053). According to Mr. Firpo, the catch basin is a dry well that collects all materials from power-washing, painting and other maintenance activities that take place on the concrete slab but does not discharge into the bay. The solids are then removed from the basin and the liquid drains to a drywell which is then pumped out as necessary. At the time of the CEI, the EPA inspectors were unable to locate the manhole and were unable to obtain any information regarding the removal of solids from the drywell. EPA personnel noted an unidentified PVC pipe inside the catch basin under the portable lift (DSCN5053). At the time of the inspection, Mr. Firpo did not have any information about where the PVC pipe discharged to. Along the bulkhead adjacent to the lift EPA inspectors observed an unknown PVC pipe (see photographs DSCN5045-DSCN5055).

outside. At the time of the CEI, facility representative Mr. Firpo could not provide information as to where the pipe discharged to. As shown in photographs DSCN5045-DSCN5055, EPA inspectors identified and unknown PVC pipe in the bulkhead adjacent from the lift catch basin. Part III.C.7.f of the Permit requires that the Facility eliminate all non-stormwater discharges not authorized by this general permit or another SPDES permit. Non-stormwater discharges that are not listed in Part I.C.3 to surface waters of the State which are not authorized by a SPDES permit are unlawful and must be terminated.

- c. Any information regarding the origin or destination of the unmarked PVC pipe in the catch basin,
 - d. Location of the drywell and manhole allegedly connected to the catch basin,
 - e. Any information regarding the Oil Water Separator,
 - f. Any additional information about the drainage on site.
3. Any information regarding the origin or determination of the unmarked PVC pipe in the bulkhead wall leading into the public bathrooms, including but not limited to;
- a. Any dye testing results and or photographs to indicate that the PVC line does or does not connect into the sink, floor drain, or toilet in the restroom,
 - b. Any design plans that indicate the connection of the bathroom drains to the sanitary sewer,
 - c. Any other additional information in regards to the PVC pipe origin and connection.

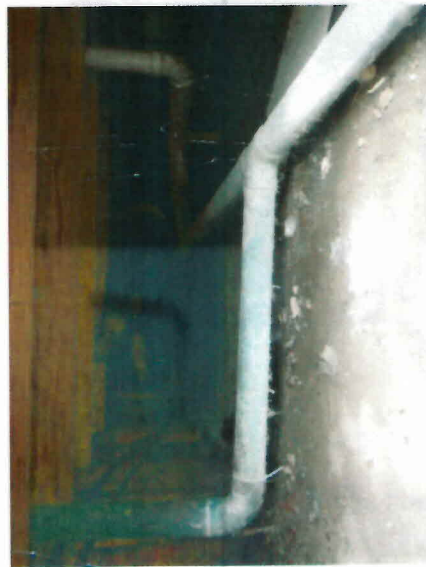
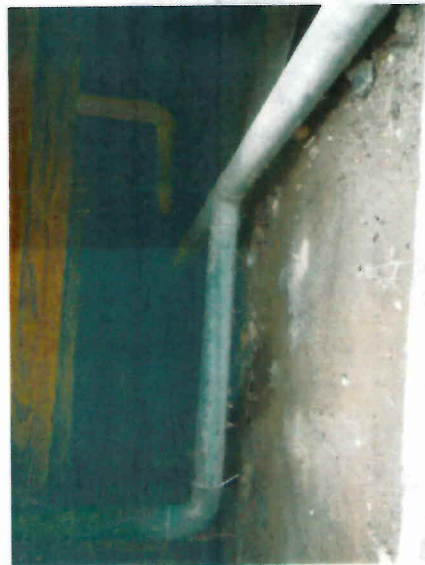
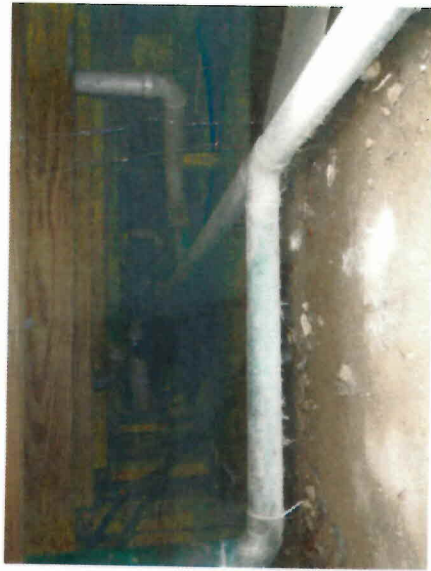
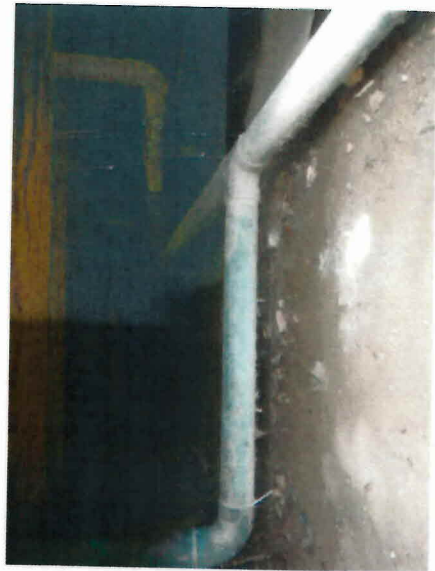
DSCN5057	Dark photo of pipe channels underneath bathroom with potential illicit discharge to bulkhead.
DSCN5058	Dark photo of pipe channels underneath bathroom with potential illicit discharge to bulkhead.
DSCN5059	Photo of pipe channels underneath bathroom with potential illicit discharge to bulkhead. Vertical pipe on right leads from floor drain and connects with vertical sink drain on the left and leads out towards the bulkhead.
DSCN5060	Bathroom adjacent from bulkhead with potential illicit connections.
